## QHSSE ADVISORY

**Advisory Number:** 2-3-US-GL-GL-00041

### Dodge 4X4 Truck Fire

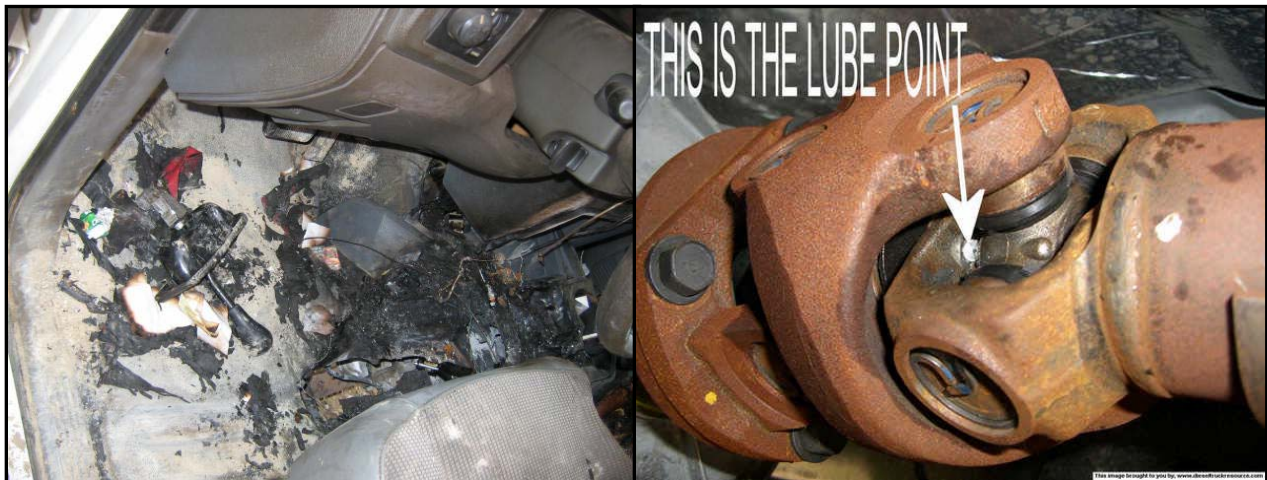
The Dodge front drive shaft turns all the time. At the transfer case end the drive shaft is made up of two u-joints and the Cardan Joint.

A Dodge Truck engineer was sent to investigate the failure. He determined the front drive shaft failed due to lack of lubrication. The resulting fire is still under investigation by Dodge.

- In most configurations, the u-joints are sealed and do not require lubrication. This might cause confusion about the lubrication of the Cardan Joint.
- The Cardan Joint in between the u-joints must be lubricated. The lubrication point requires a special grease fitting and is hard to see.

- All Dodge 4X4 vehicles should be inspected by a competent mechanic to determine the current condition as soon as possible.
- Ensure the lubrication service provider knows how, and is capable of, lubricating this joint during routine maintenance.
- Follow the owner's manual for preventative maintenance requirements.
- Carry this advisory in the Dodge vehicles to notify lubrication providers of where the lube point is.
